3838 PST/Gel Buried Service Wire Splice Kit

Technical Report

May 1996

Issue 2, 80-6108-4826-1

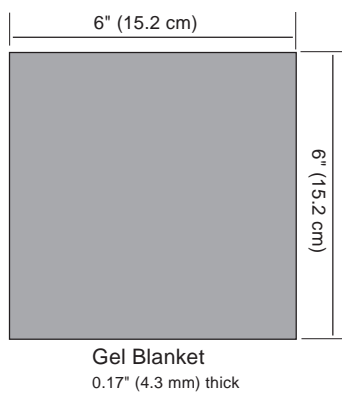
3M™ 3838 PST/Gel Buried Service Wire Splice Kit Components

The 3M™ 3838 PST/Gel BSW splice kit will accommodate up to six pair buried service wire with a maximum diameter of 0.45 in. (11.4 mm) in either an in-line or butt splice configuration. Maximum diameter of a cable up to 0.65 in. (16.5 mm) can be used with the kit if a 3M™ Scotchlok™ 4460D shield bond connector is used. A 3M™ Scotchlok™ 4463 Service Wire Shield Connector and strain relief clamp are included for easy shield bonding, splice protection and strain relief to the buried service wires. The parts included in each kit and their dimensions are illustrated in the diagrams shown on the next page.
